**AFRL-ML-WP-TR-1998-4133**

**PROCEEDINGS OF THE 1997 USAF  
AIRCRAFT STRUCTURAL INTEGRITY  
PROGRAM CONFERENCE**

**VOLUME I**

**USAF Aircraft Structural Integrity Program Conference  
Hyatt Regency San Antonio  
San Antonio, Texas**

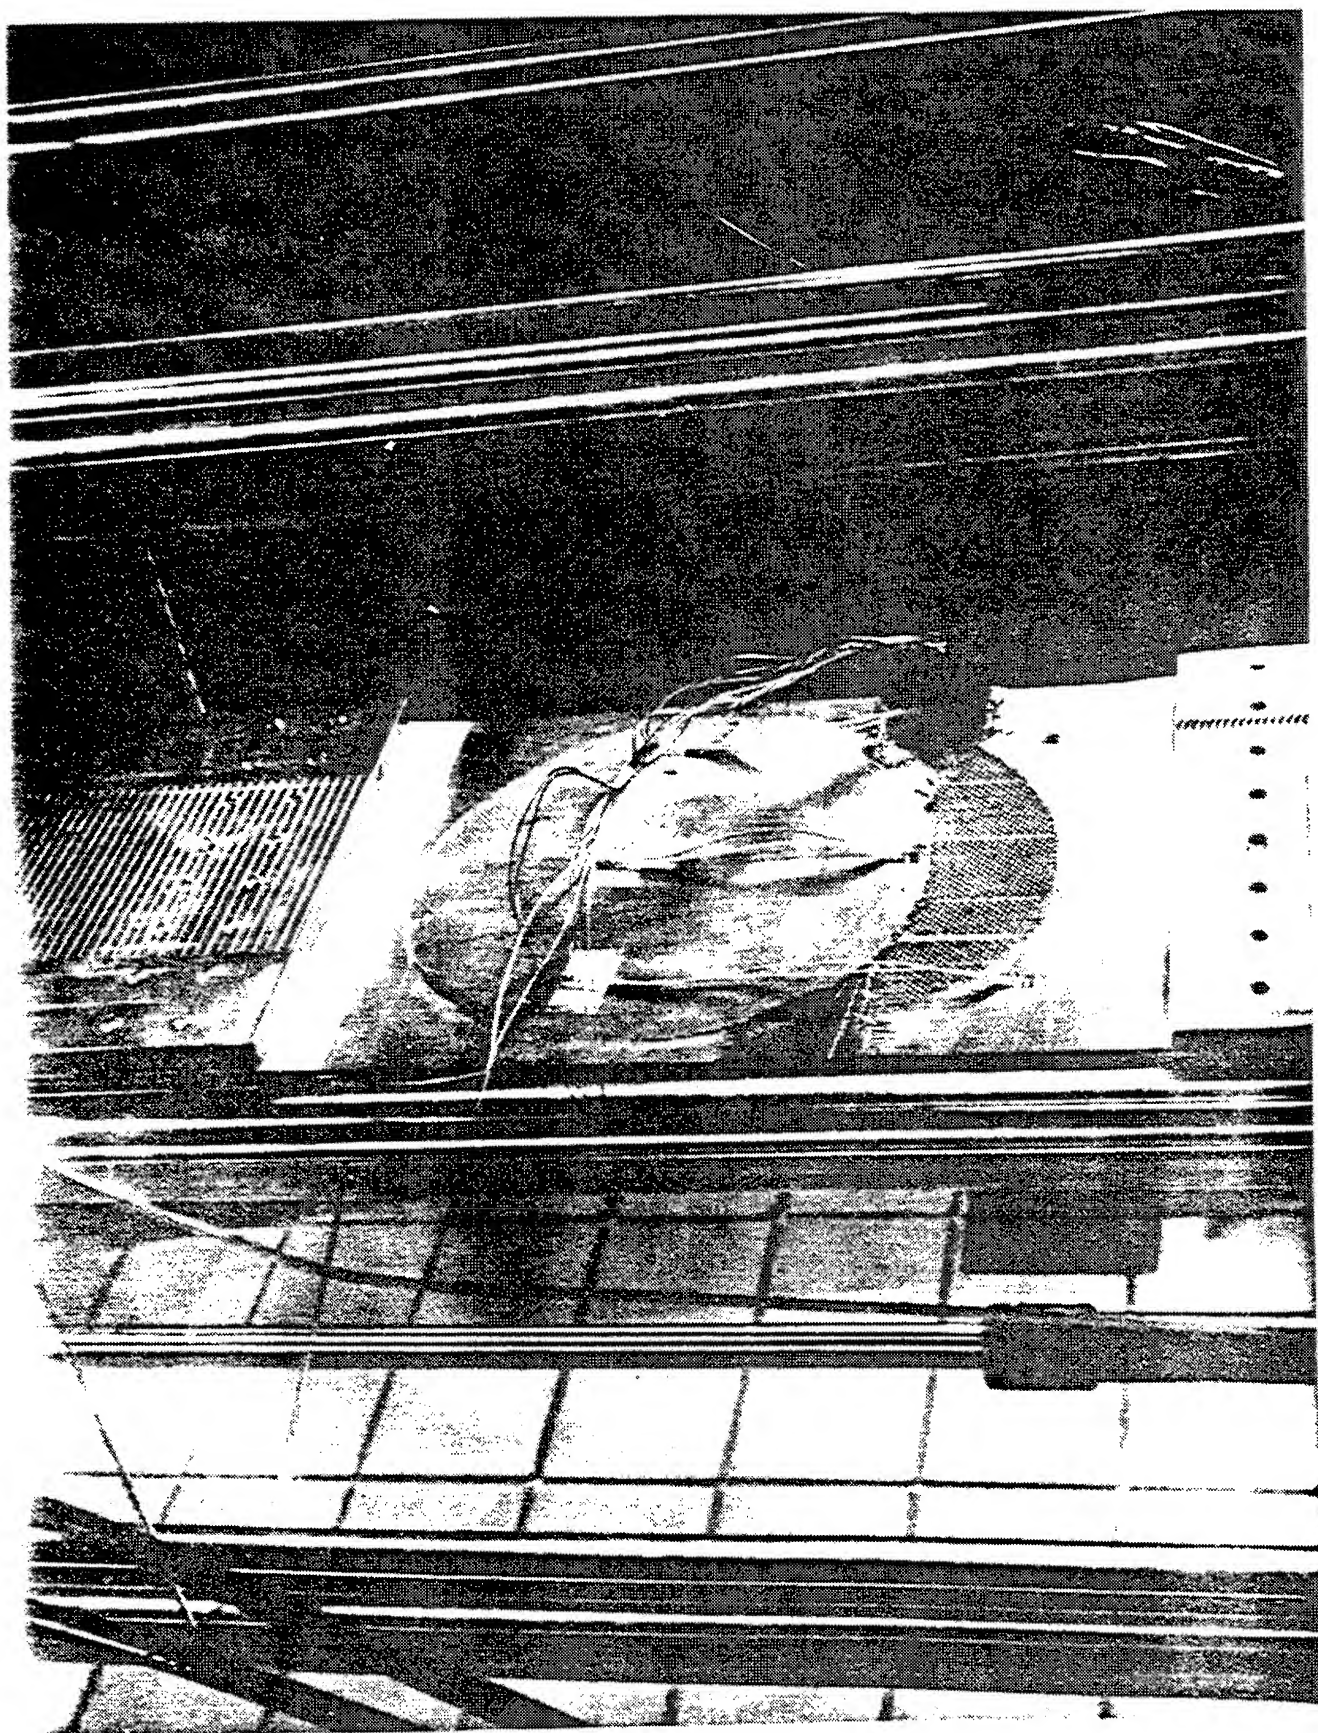
12" SOLID LAMINATE TENSION TEST - 2 SIDED REPAIR
